ELDEAN BRIDGE
(Allen's Mill Bridge)
Spanning Great Miami River at bypassed section of Eldean Road
Troy vicinity
Miami County
Ohio

HAER OH-122
OH-122

STRUCTURAL
TYPE: Long through truss covered bridge

SIGNIFICANCE: Eldean Bridge is one of the best surviving examples of a Long
truss, patented by Col. Stephen H. Long in 1830. Long was the
first American engineer to apply the concept of driving wedges
into the connections to prestress the structure, ensuring that the
members functioned efficiently.

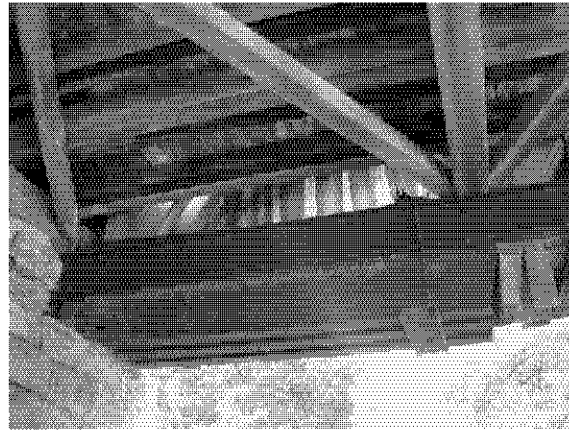
Fig. 7: Detail of the support at the abutment. Field photograph, 2002.

A site inspection of the bridge revealed that I-beams (three for each bottom chord) now support the spans. At the abutments these I-beams are fixed in concrete and tied to the bottom chords (see Fig. 7). This arrangement can resist both vertical and horizontal displacements, so they were modeled as pin connections. At the central pier, each truss is similarly supported on I-beams, except that these connections allow for some degree of horizontal displacement. These were modeled as roller-type connections.

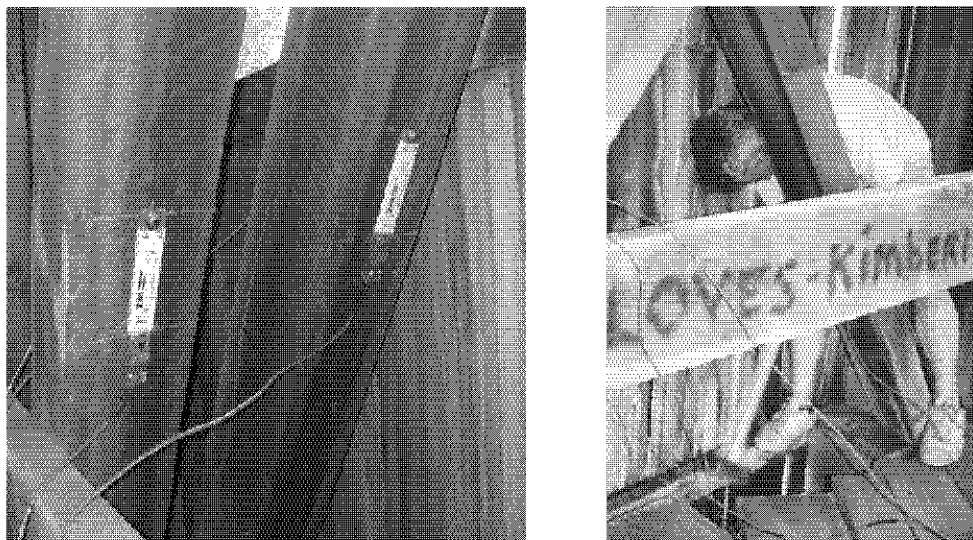
Fig. 23: View of the main diagonal instrumented with strain gages on left; Driving a wedge against a counterbrace on right. Field photographs, 2002.

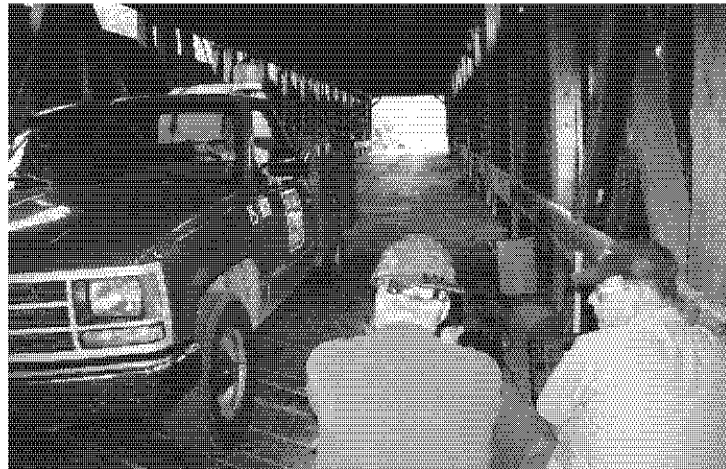
Fig. 25: Live load testing with the 7,900 lb truck. Field photograph, 2002.
